# MAINTENANCE BULLETIN

NO. 159  
AUGUST 1998

## ALFA COMPANY

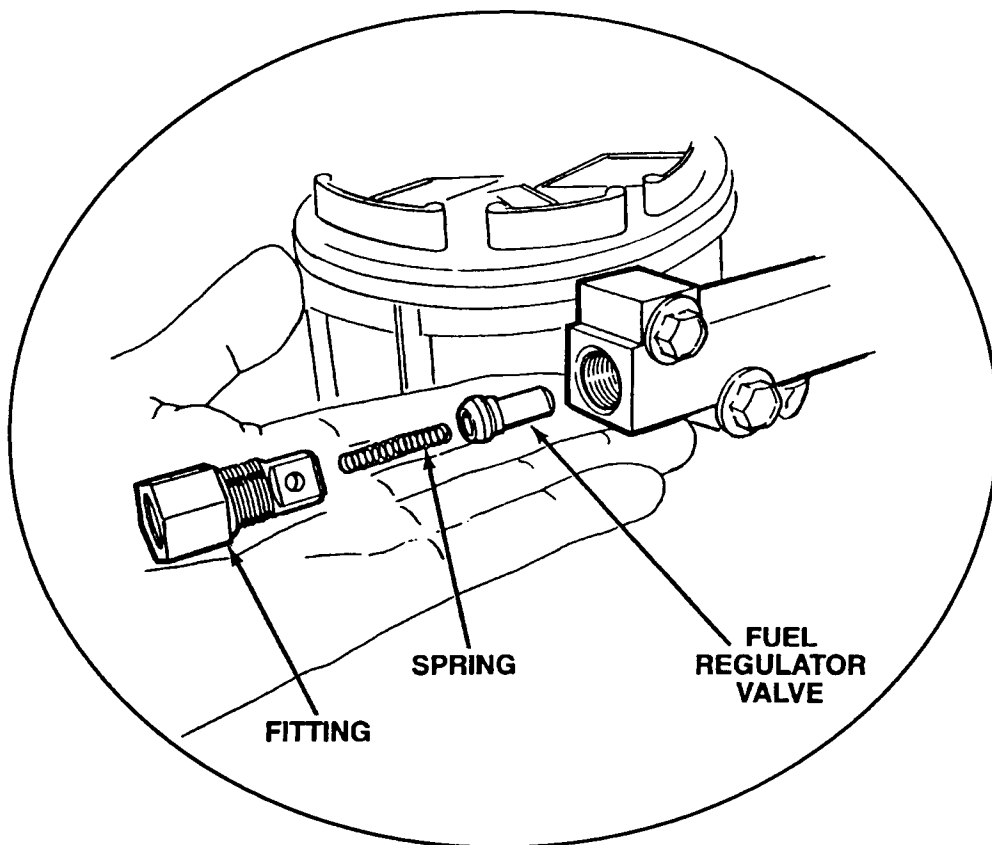
Figure 3. – Fuel Regulator Valve

An engine knocking sound, "cackle" some times described as a fuel knock or connecting rod knock, can be caused by the fuel regulator valve sticking or debris caught in the seat. Fuel transfer pump pressure that drops below 35 psi at idle can aggravate the "cackle" concern. Disassemble the regulator (See Figure 3) and inspect for sticking, debris or broken spring, replace if necessary with regulator valve package (P/N 1823641C91). Remove the fuel supply line from the 3-way fitting at the fuel supply pump (Figure 2A) and inspect the supply line rubber seal, replace if necessary (P/N 1812348C1). When installing a new seal the metal tube should be bottomed in the fitting in its normal position while the tube retainer nuts are tightened.
